Asbestos Log-Book

Head of School: Mr Nick Kerin
Log-Book updated in November 2018.

St.Louis Catholic Academy, Newmarket	Asbestos Register
	2018 Revision

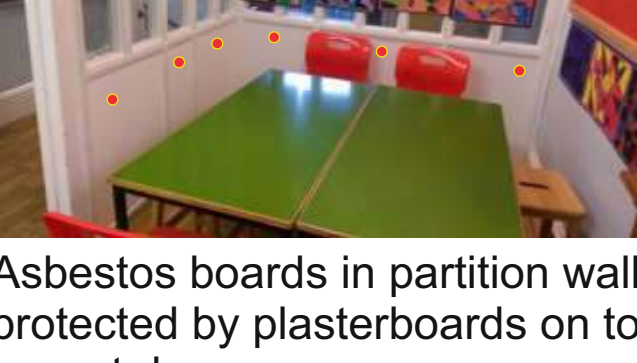
Inspection point n 33

Asbestos boards in partition wall: the asbestos is protected by plasterboards on top to prevent impact damage.

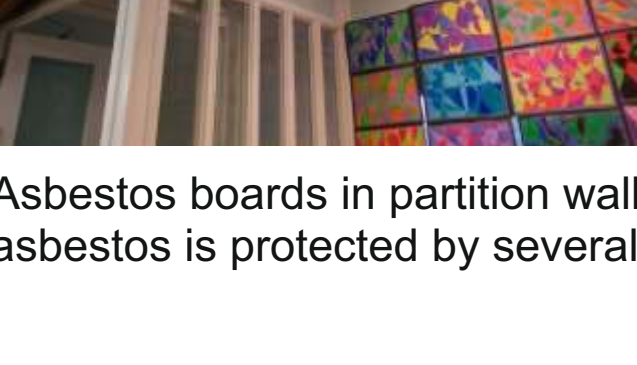
Inspection point n 33

Asbestos boards in partition wall (top): the asbestos is protected by several coats of paint.

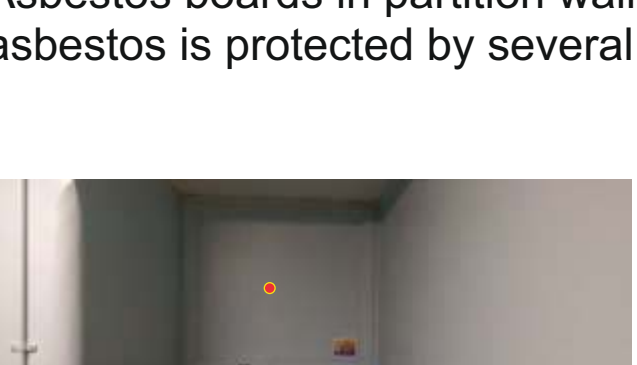
Inspection point n 33

Asbestos boards in partition wall (top): the asbestos is protected by several coats of paint.

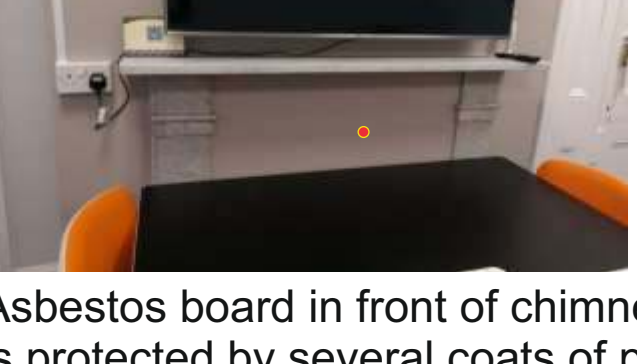
Inspection point n 12

Inspection Point	Block-Floor-Area	Location & Size	Material Type	Risk Rating	Comments
12	Old Building First Reprographic	Wall panel to rear of cupboard (0.5 m2)	Amosite & Chrysotile	12	Cupboard is closed and sealed
15	Old Building First Stairwell landing	Panel above door to corridor (0.5 m2)	Amosite & Chrysotile	8	Painted over
21	Old building First CEO	Blanking panel to fireplace (1 m2)	Amosite & Chrysotile	9	ACM is wallpapered over
26	Old building First Maple Class	Sink pad (0.25 m2)	Chrysotile	8	
29	Old Building First Larch Class	Sink pad (0.25 m2)	Chrysotile	7	
31	Old Building First Hazel Class	Sink pad (0.25 m2)	Chrysotile	7	
33	Old Building First Main Stairwell	11 infill panels (1 m2)	Amosite & Chrysotile	10	ACMs covered with boards for extra protection
37	Old Building Ground Beech Class	Sink pad (0.25 m2)	Chrysotile	7	
39	Old Building Ground Elm Class	Sink pad (0.25)	Chrysotile	7	
77	Old Building Basement Boiler room	Panel adjacent to door (2 m2)	Amosite & Chrysotile	12	Painted over

Asbestos board attached to wall at the bottom: the asbestos is protected by several coats of paint and the cupboard door is closed with screws.

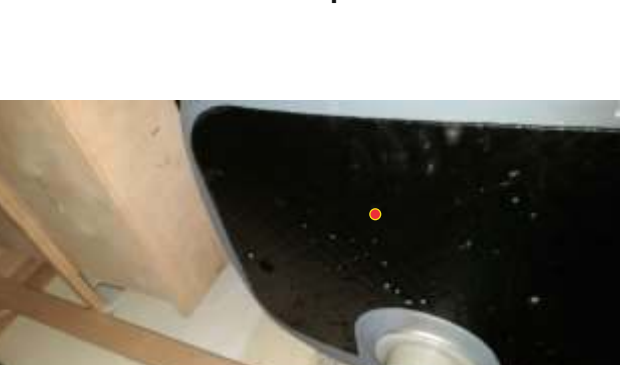
Inspection point n 31

Asbestos rubber pad under the sink

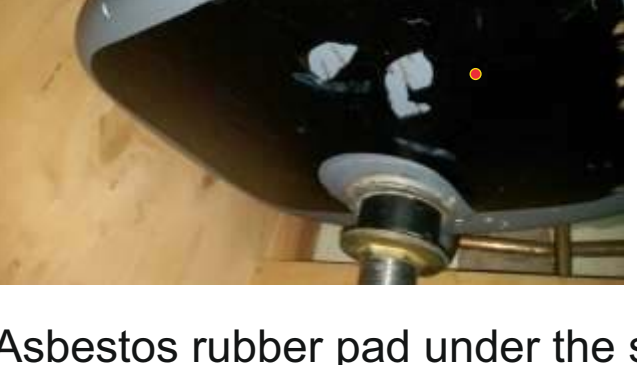
Inspection point n 29

Asbestos rubber pad under the sink

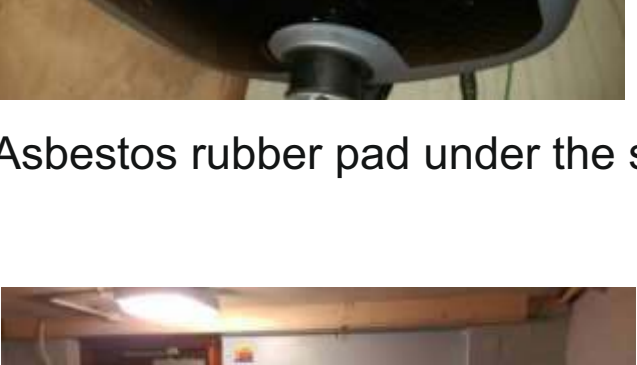
Inspection point n 26

Asbestos rubber pad under the sink
